# UNDERWATER BRIDGE INSPECTION REPORT

STRUCTURE NO. 73533

CSAH NO. 71

SAUK RIVER

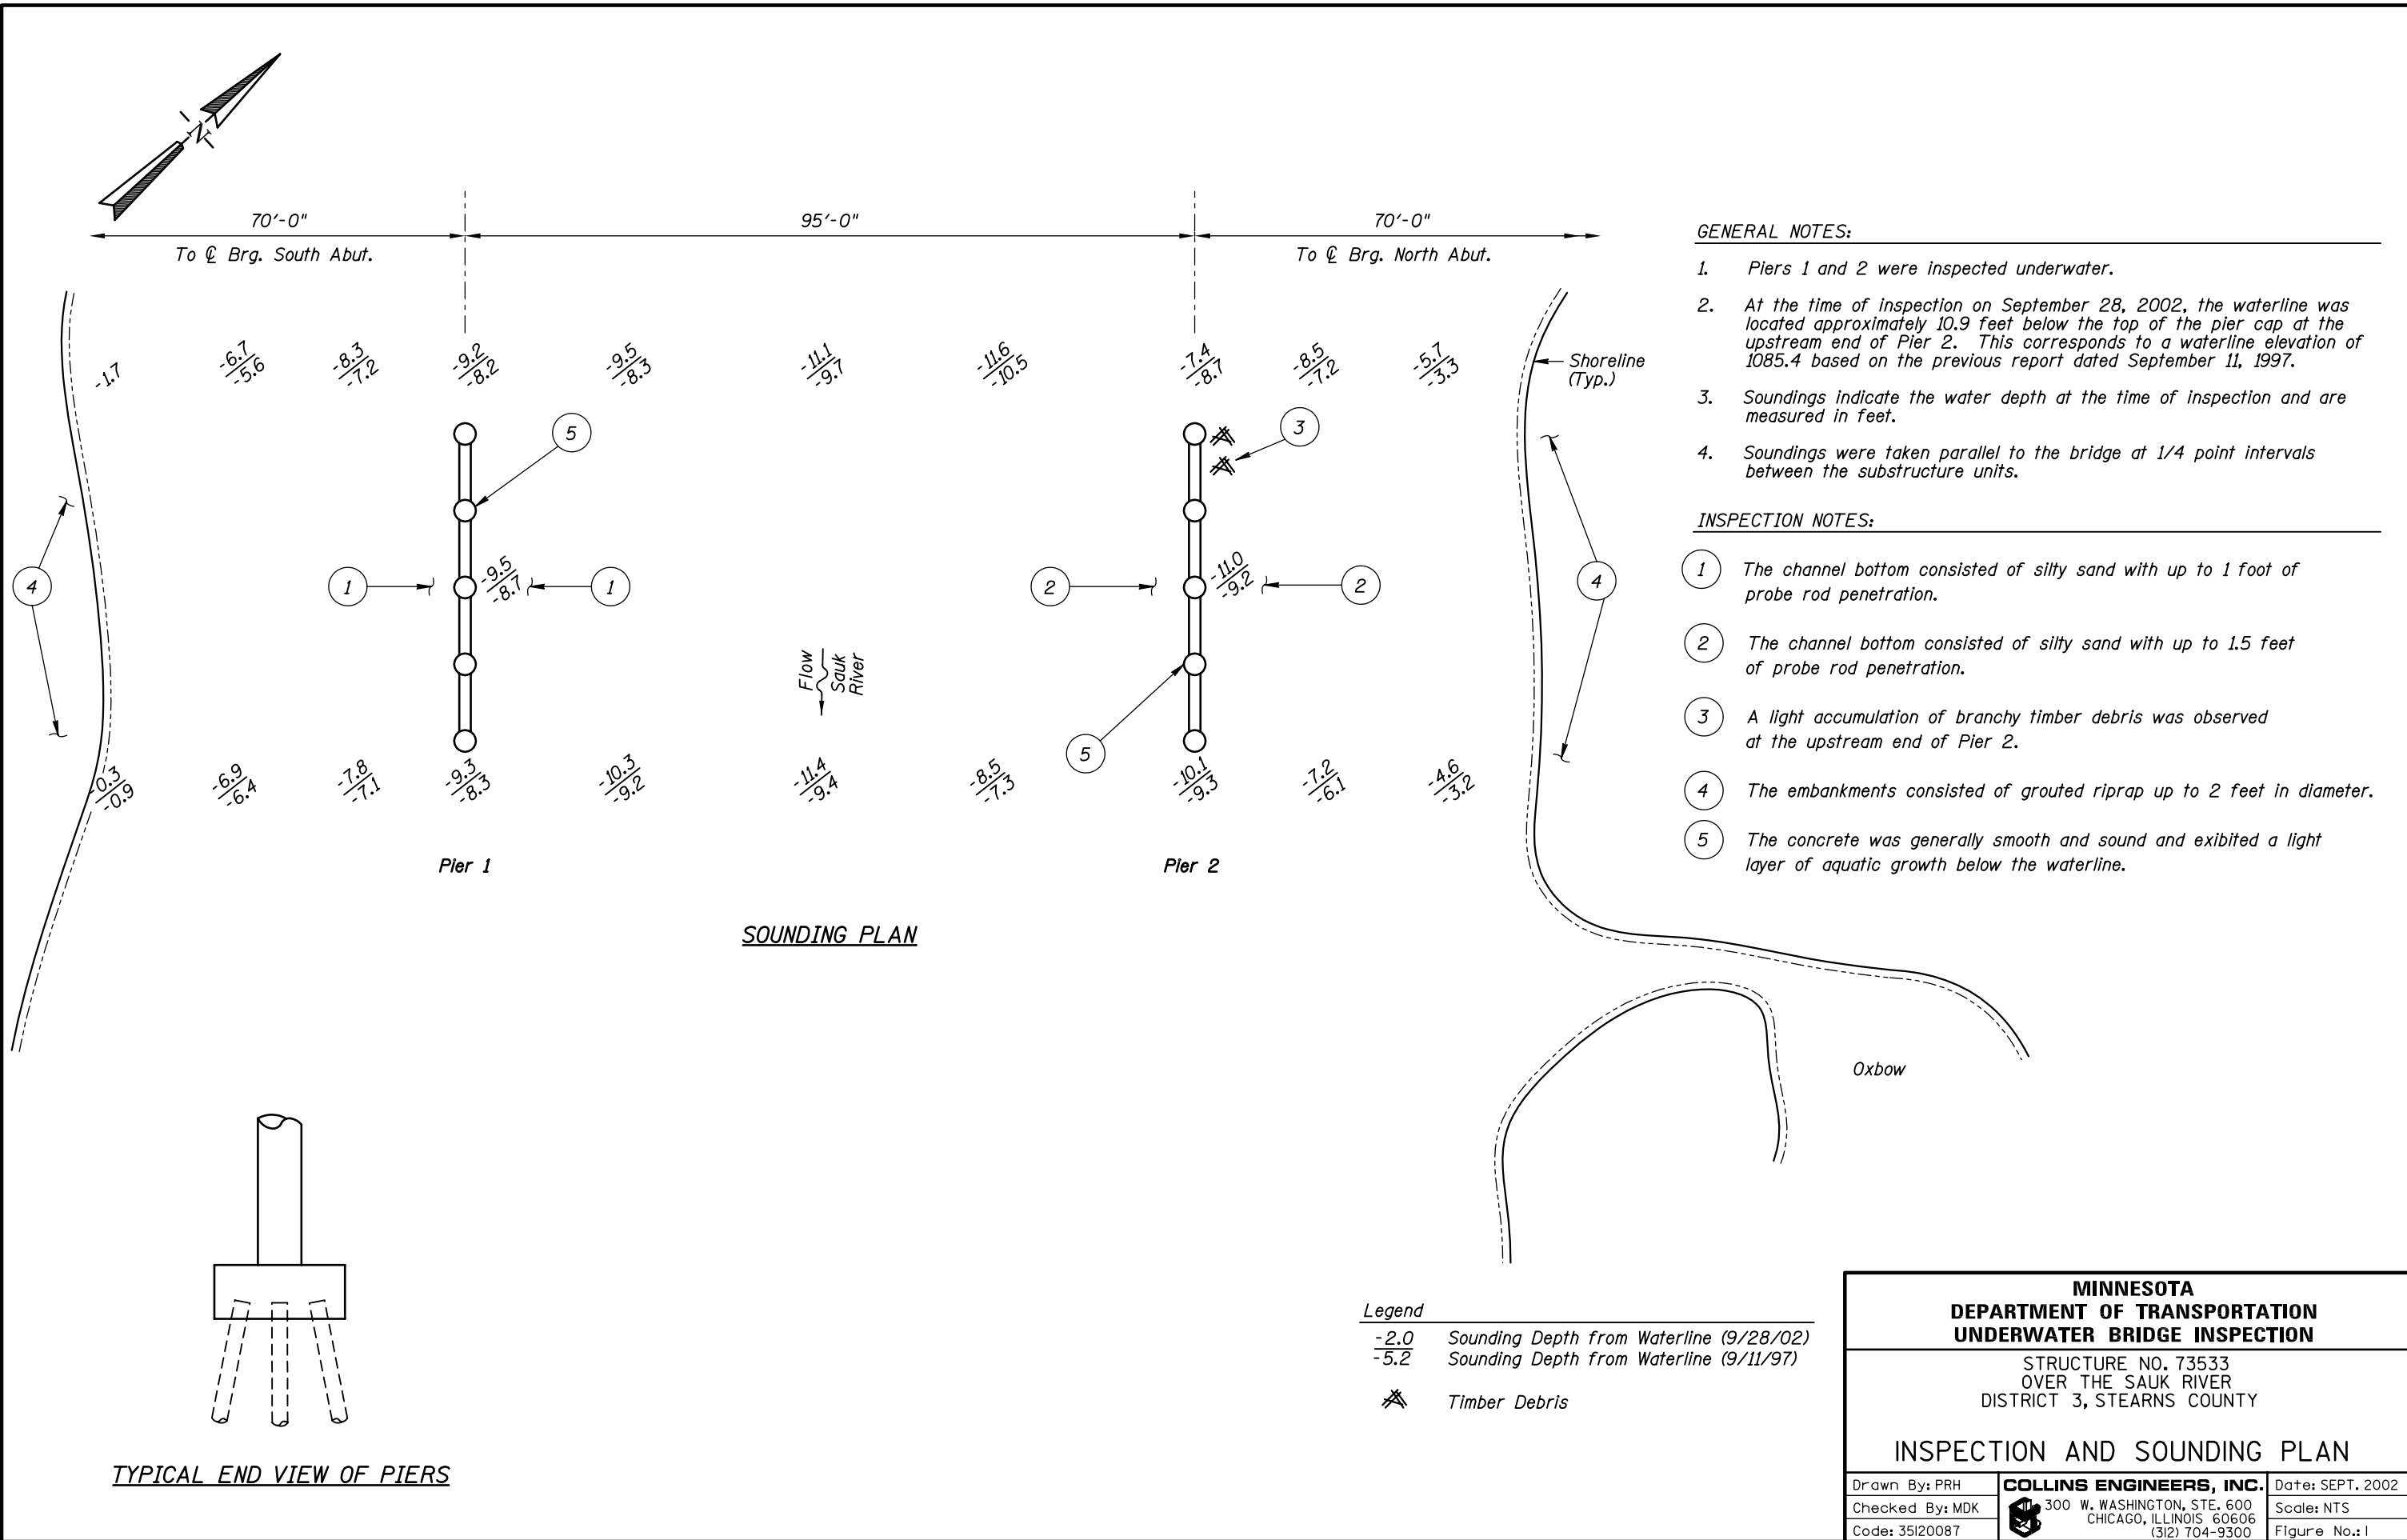
UPSTREAM FASCIA PROFILE

REMARKS: Overall, the concrete was sound and in very good condition with no notable defects. A minor accumulation of branchy timber debris was observed along the upstream nose of Pier 2. The channel bottom appeared to be in stable condition with no appreciable changes observed since the previous inspection.

Reinspect the submerged substructure units at the normal maximum recommended (NBIS) interval of five (5) years.
